SAMPLE INSPECTION REPORT

Built in 1983, this occupied zero lot line home has 2 bedrooms, 1 bathroom, deck, and off-street parking.

5 May 2016 / 000 Fast Leaf Cir / Anchorage AK 99500

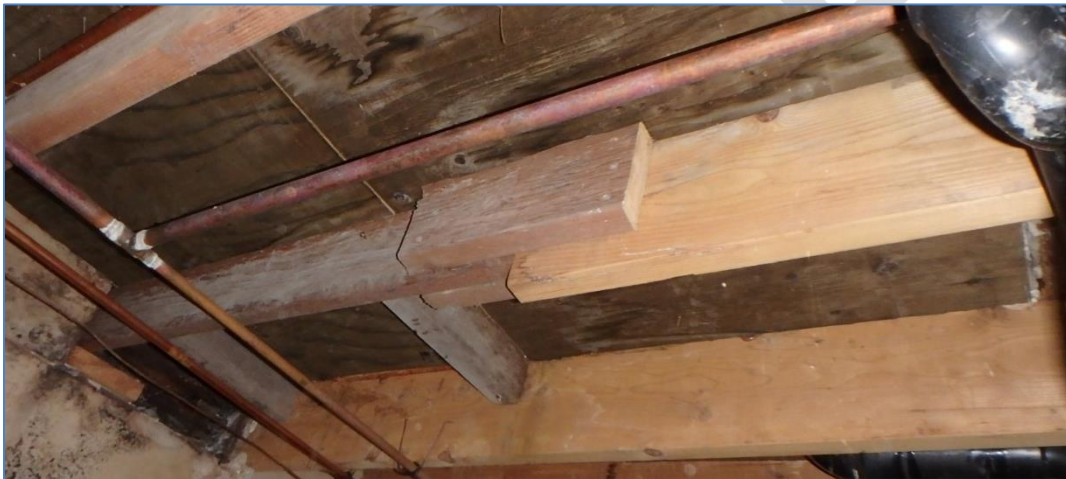
1. A floor joist under the bathroom was cut but the repair is inadequate. Install a header to support the floor joist OR install an 8' long scab glued and screwed.

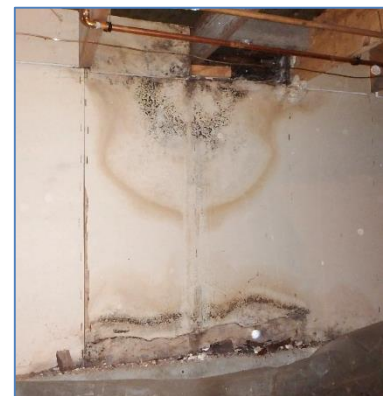
4. Remove mold from walls and windows.
5. Remove mold from the drywall firewall in the crawlspace.
6. Dishwasher hasn't been used by the homeowner for more than 20 years. Seals are likely deteriorated. Replace the dishwasher.

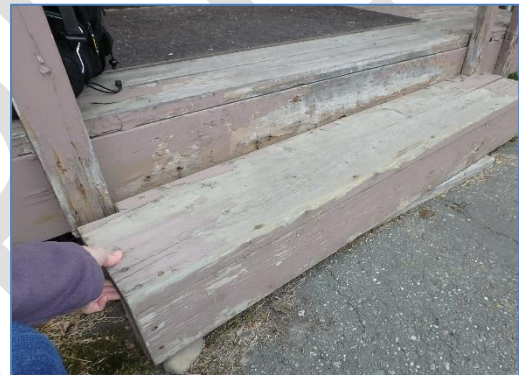
2. Front deck baluster spacing exceeds the current standard. Modify the infill panels so a 4" sphere can't pass through (note: the railing isn't required).
3. Remove loose paint on the front entry deck.
4. Replace the rotted deck board at the front deck.
5. Level and secure the step at the front entry deck.

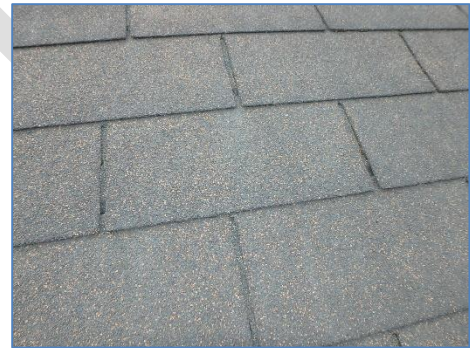
Roof was accessed by ladder. Composition shingles are in good condition and have more than 5 years life left. Roof penetrations appear to be in good condition. Flashing is intact where visible.

Rain gutters and downspouts help control rainwater from the roof. Install long extenders on downspouts to discharge water farther from the foundation but remove them for winter.

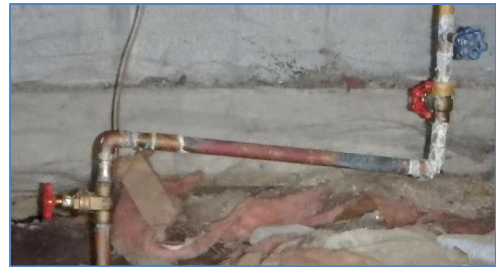
Main Shutoffs: Main water shutoff (red handle) is located in the crawlspace under the living room. All fixtures except the tub have individual shutoff valves. The natural gas main shutoff is located at the meter at the right side of the house.
